User: Energy plant KONIN
Supervisor: Ing. Piotr Anioła–Chester Molecular- Poland
Date: August 2013

DESCRIPTION OF THE PROBLEM:

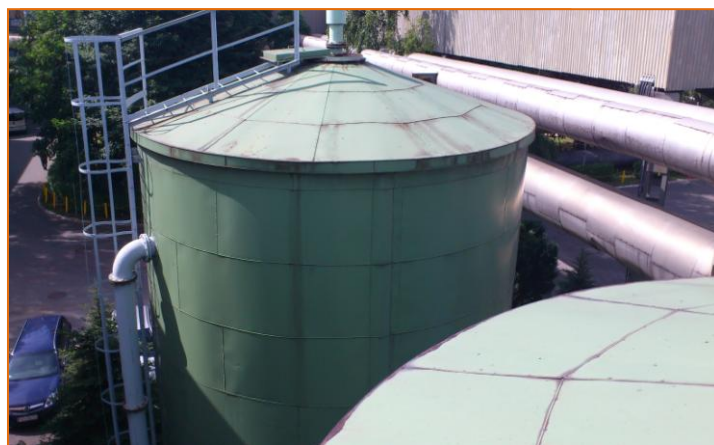
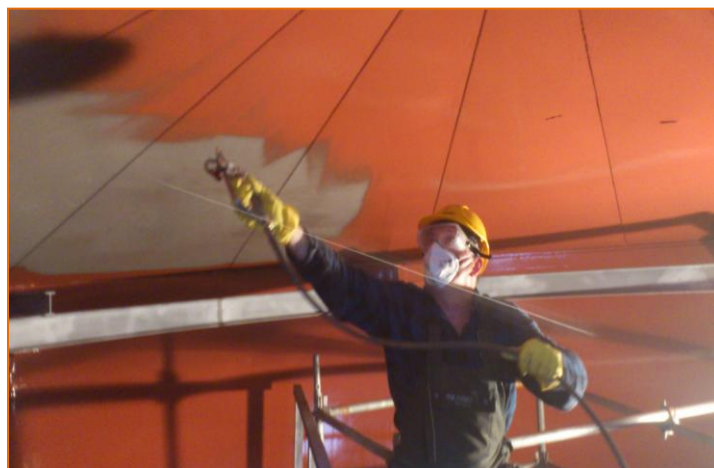
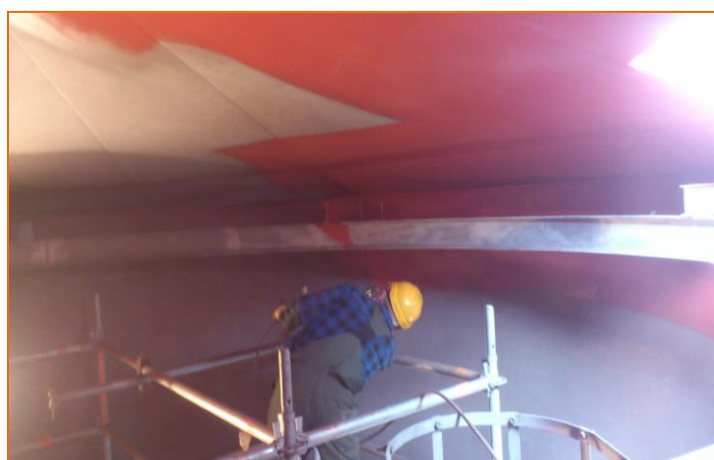
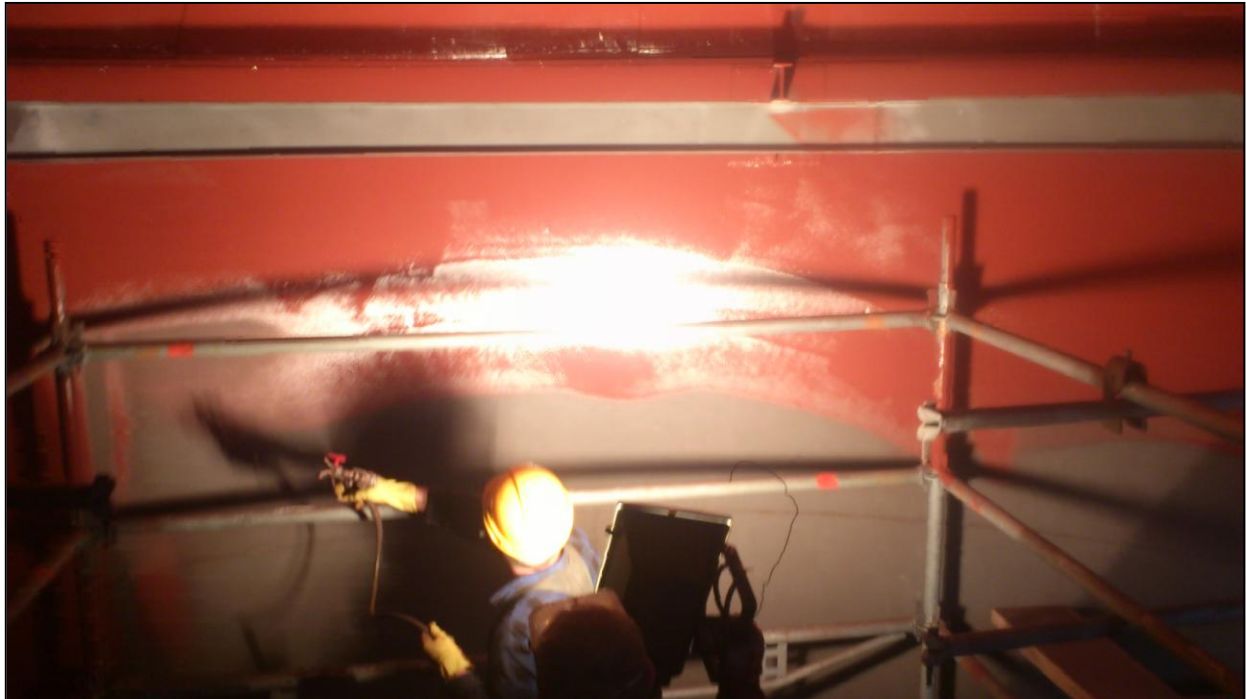
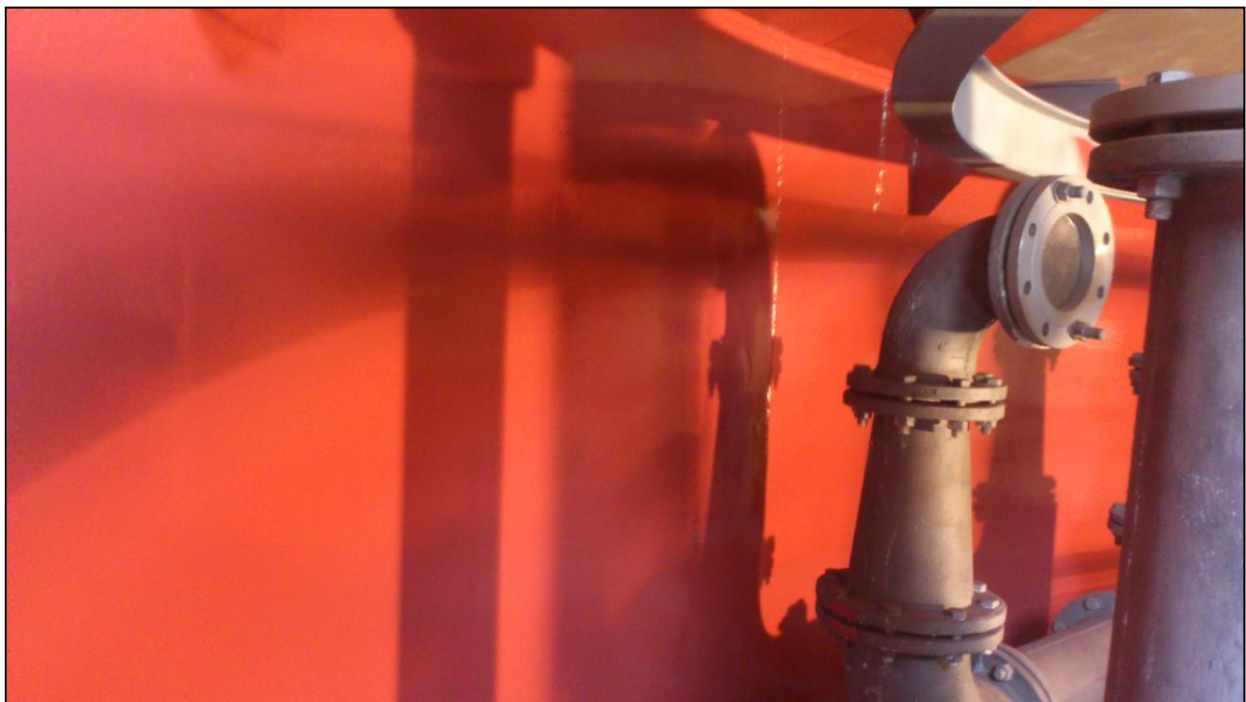
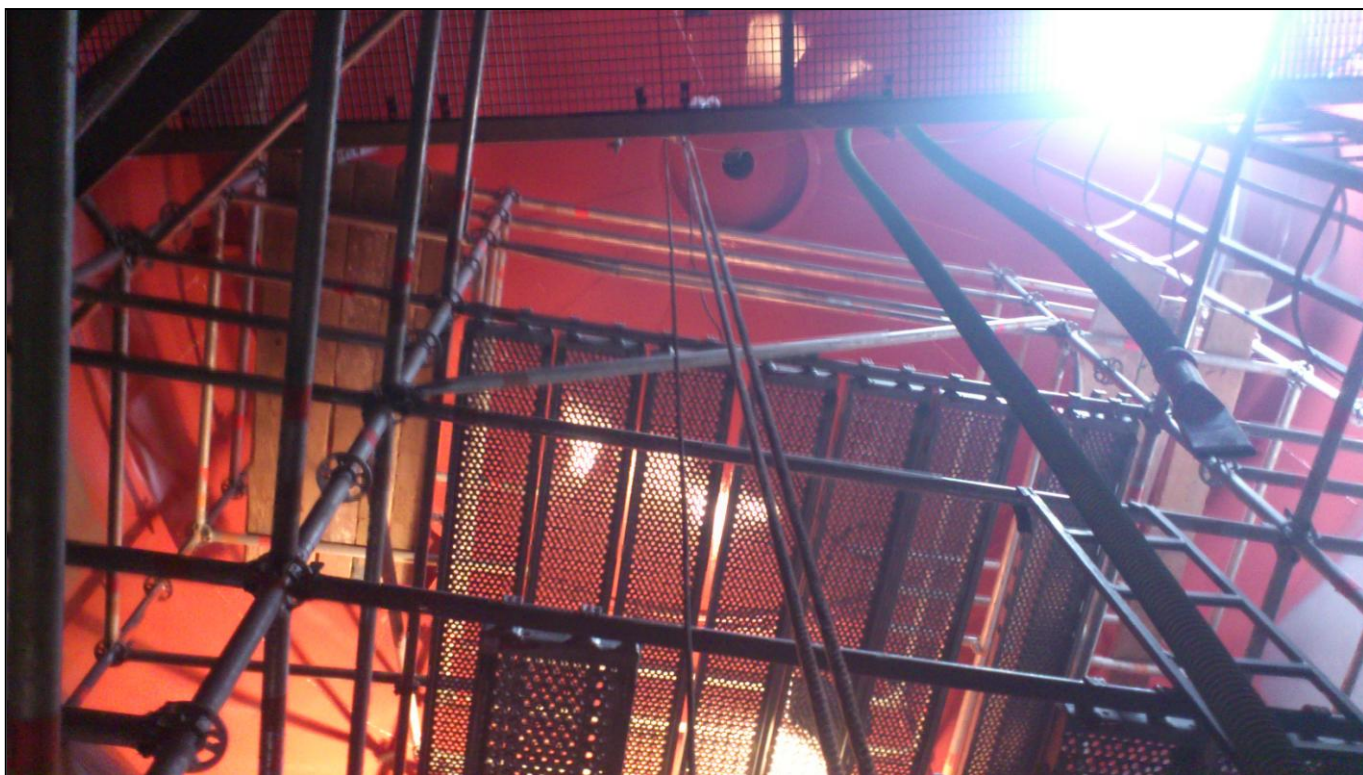
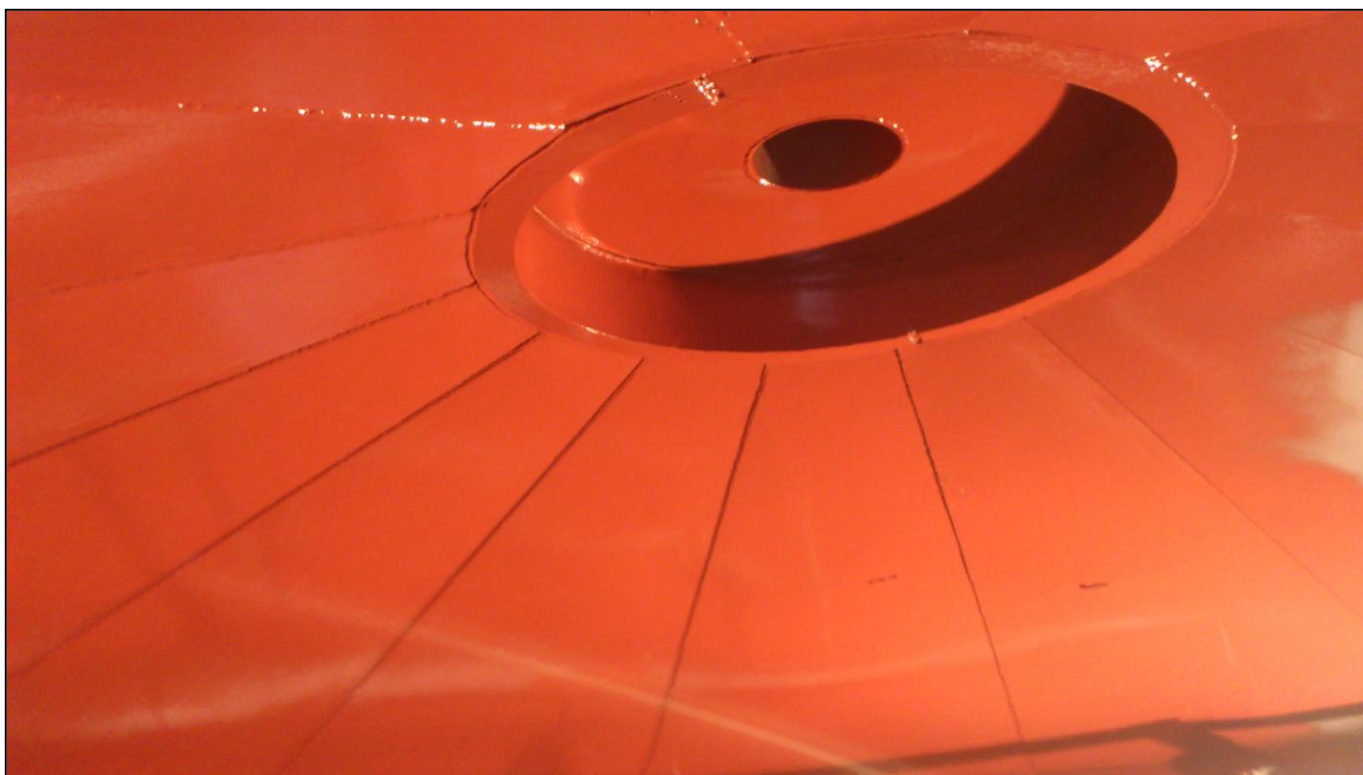
It is needed to protect 250m³ tank of water, intended for drinking water supply against corrosion in a power plant. Due to the large size of tank we have decided to use Chester D1/D2 protective coating system with corrosion inhibitors for airless application.

We proceeded to prepare the surface by sanding to get a clean and rough surface. After cleaning the tank, it took three days to make whole application inside the tank. The first layer was made with Chester D1 Coating (red oxide color) and the second, protective layer was made with Chester D2 Coating (gray color). Coating D1 is firstly applied on the roof and the sides, and then Coating D2 in applied on the same areas – both D1 and D2 was applied with airless method. After removing the scaffolding inside the tank it is time to protect the bottom with both Chester Coatings. The tank had a height of 10 meters with a diameter of approx. 6 meters.

The repair was done in just 3 days once the surface was sandblasted. We have obtained a quick and perfect corrosion protection with 100% solids, without any solvent in D1/D2 Chester Coating, suitable for use in contact with drinking water.
